CORROSION FATIGUE OF 2024-T4 ALUMINIUM ALLOY  
IN CONTACT WITH SUPERPHOSPHATE FERTILIZER

A thesis presented for the  
degree of Doctor of Philosophy in Mechanical Engineering,  
in the University of Canterbury,  
Christchurch, New Zealand.

by  
N.A. MILLER  
1968

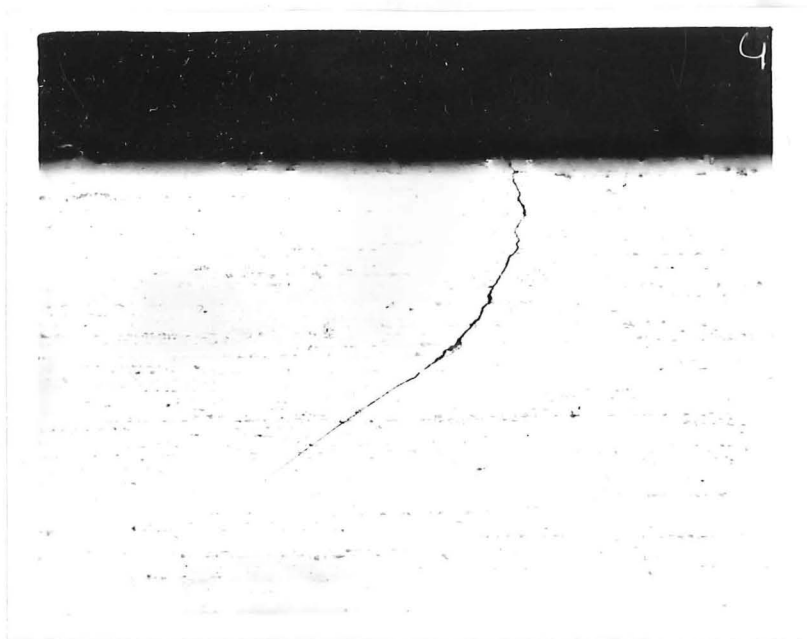
Figure 7/4: Photograph (x50) showing an air fatigue crack. Stress level 19 tsi, cycles  $1 \times 10^5$

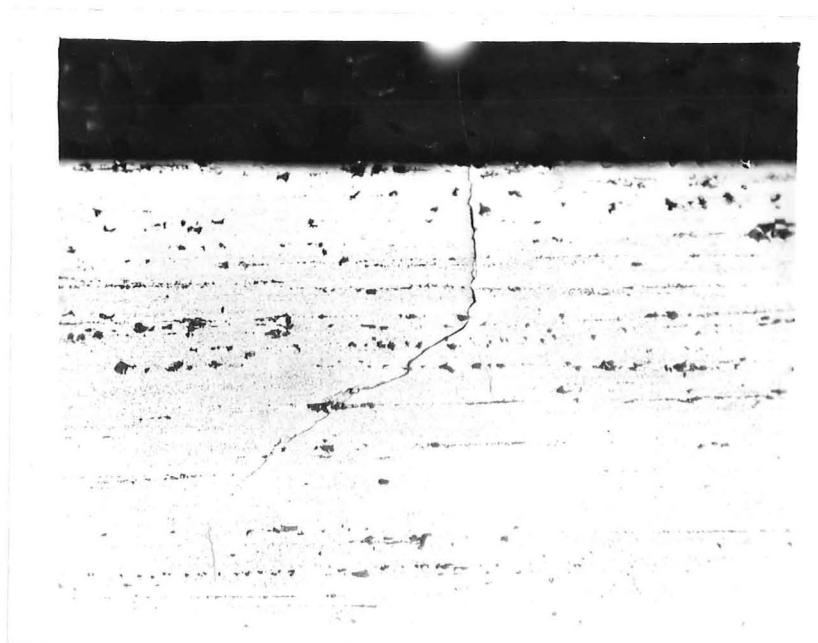
Figure 7/5: Photograph (x50) showing an air fatigue crack. Stress level 16 tsi, cycles  $2.2 \times 10^6$

At the transition of the tensile mode to the shear mode of crack growth, the crack has two possible  $35^{\circ}$  planes (at  $90^{\circ}$  to each other) on which it can propagate. Under these circumstances it should be possible for two shear mode cracks to be formed and in several sectioned specimens this feature has in fact been observed. However one crack normally becomes dominant and propagates rapidly while the other crack apparently becomes non-propagating. Which crack becomes dominant is probably determined by local stress and micro-structural details. Figure 7/5 shows the formation of two shear mode cracks with

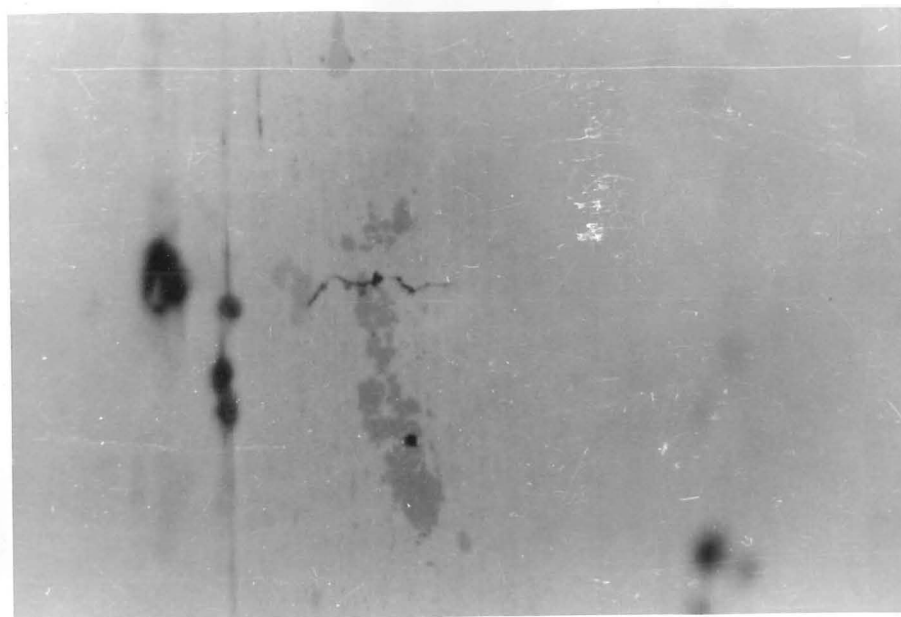
Figure 7/7: Initiation area of air fatigue crack on polished specimen. Crack initiates from CuAl<sub>2</sub> particle. x150.

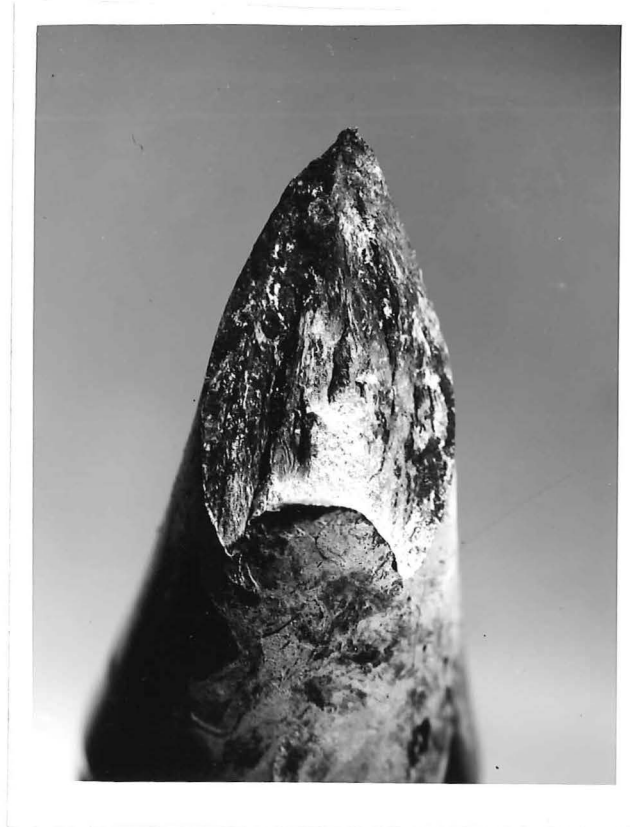
Figure 7/11: Photograph of a corrosion fatigue fracture, showing how the crack propagates faster at the edges of the specimen than in the centre.

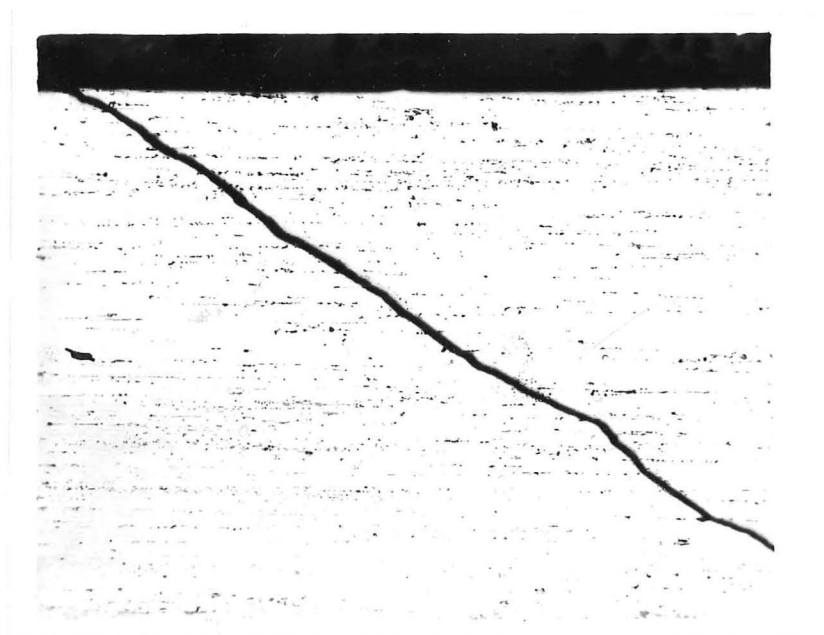
Figure 7/13: Photomicrograph of a typical corrosion fatigue crack, showing shear mode of failure. x50.

As with the air tests a number of corrosion fatigue tests were conducted until surface cracks were detected visually. These specimens were then sectioned and examined metallographically. Figures 7/12 - 7/15 show features of the corrosion fatigue cracks revealed by metallographic examination. Figures 7/12 and 7/13 which are sections along the specimen axis
